JUSTICE AND PUBLIC SAFETY CABINET

INCIDENT REVIEW OF IN-CUSTODY FATALITY

EKCC was built between 1986 and 1991 and began housing inmates in February of 1990. The prison is designed to hold 1,914 inmates and covers 157 acres. The Toxic building, where the incident occurred, was part of the original construction. The Toxic building is located outside the secure perimeter of EKCC next to a staff parking lot.

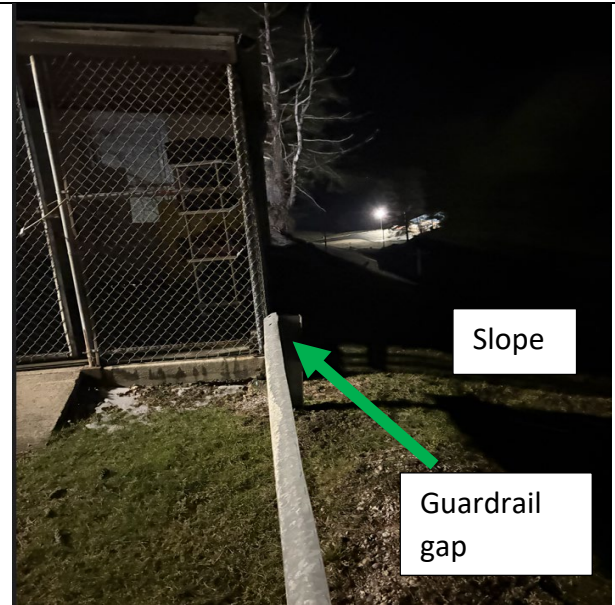
Figure 3: Side of Toxic building where Inmate Knuckles fell (night). Photo taken 2/12/2026

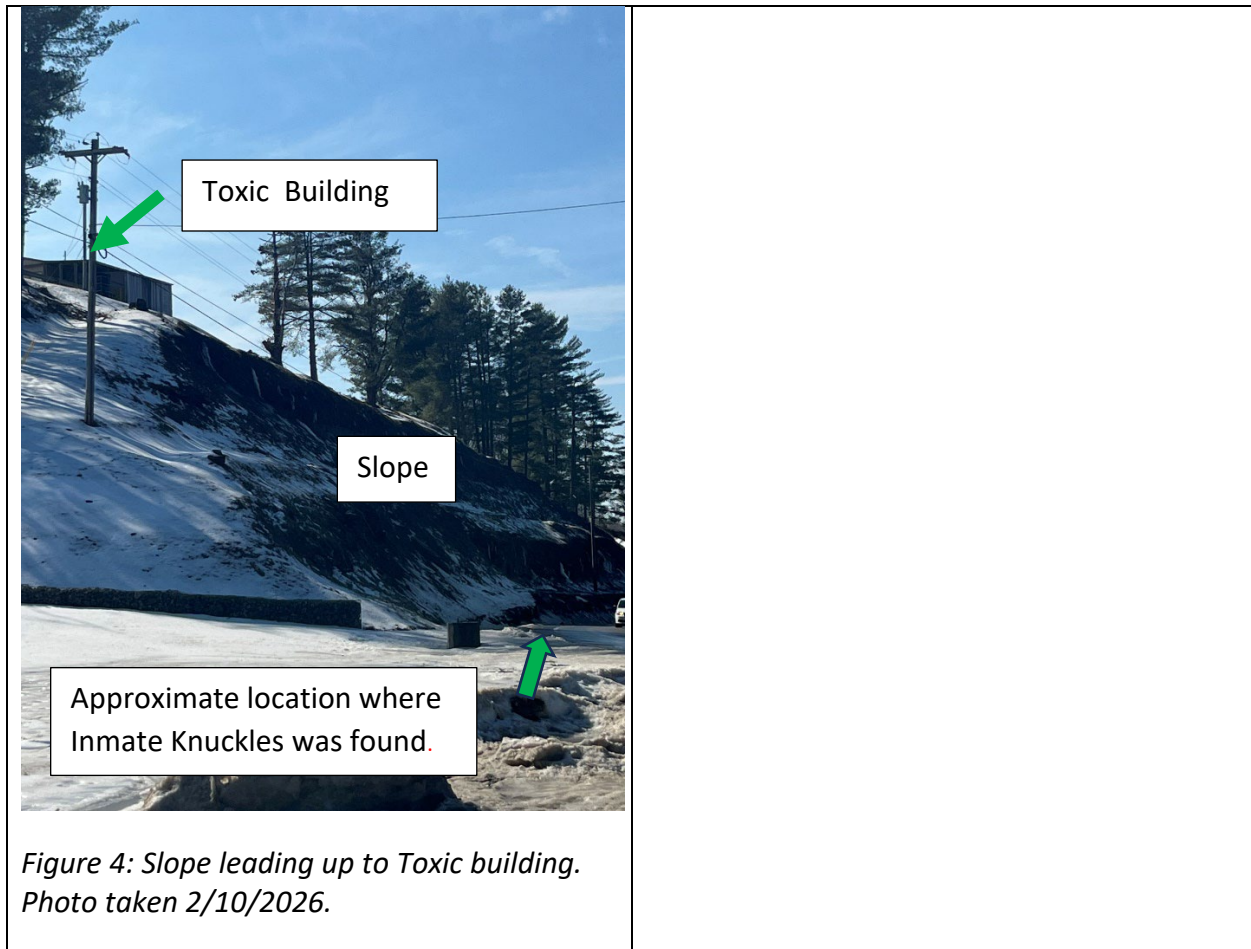
The slope is only accessible by stepping over a guardrail or walking through an approximate 12-inch gap (see Figures 5 and 6) between the end of the guardrail and a fenced storage area attached to the building. There are no warning signs next to the guardrail. An exact measurement of the sloped area in which Inmate Knuckles fell, or the distance of the fall, could not be safely obtained due to the snow and ice on the slope at the time of the review.

The CIR team recommends installing a 6-foot-tall fence with top and bottom rails in the area adjacent to the slope to protect personnel and equipment from future accidents. The CIR team also recommends that signs be posted at each end of the fence that state “No entry beyond this point – Dangerous Slope”. Additionally, the fence should be installed so that no one can pass between it and the building.

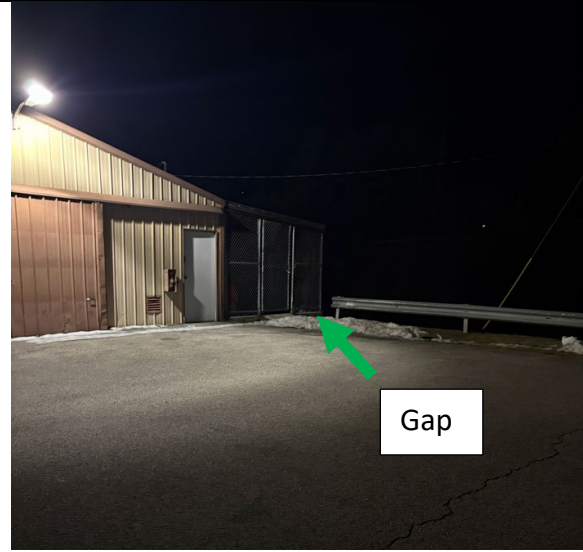
Figure 6: Gap between right front corner of Toxic building and guardrail (night). Photo taken 2/12/2026.

Video footage from the night of the incident shows that the light on the front of the Toxic building was on at the time of the incident. Given that a light was on the front of the building and that Inmate Knuckles is suspected to have stepped through the gap between the guardrail and the corner of the building that led to the icy slope, and the light shines in the area of the gap between the shed and the guardrail, the review team does not believe the lighting was a contributing factor to the incident.

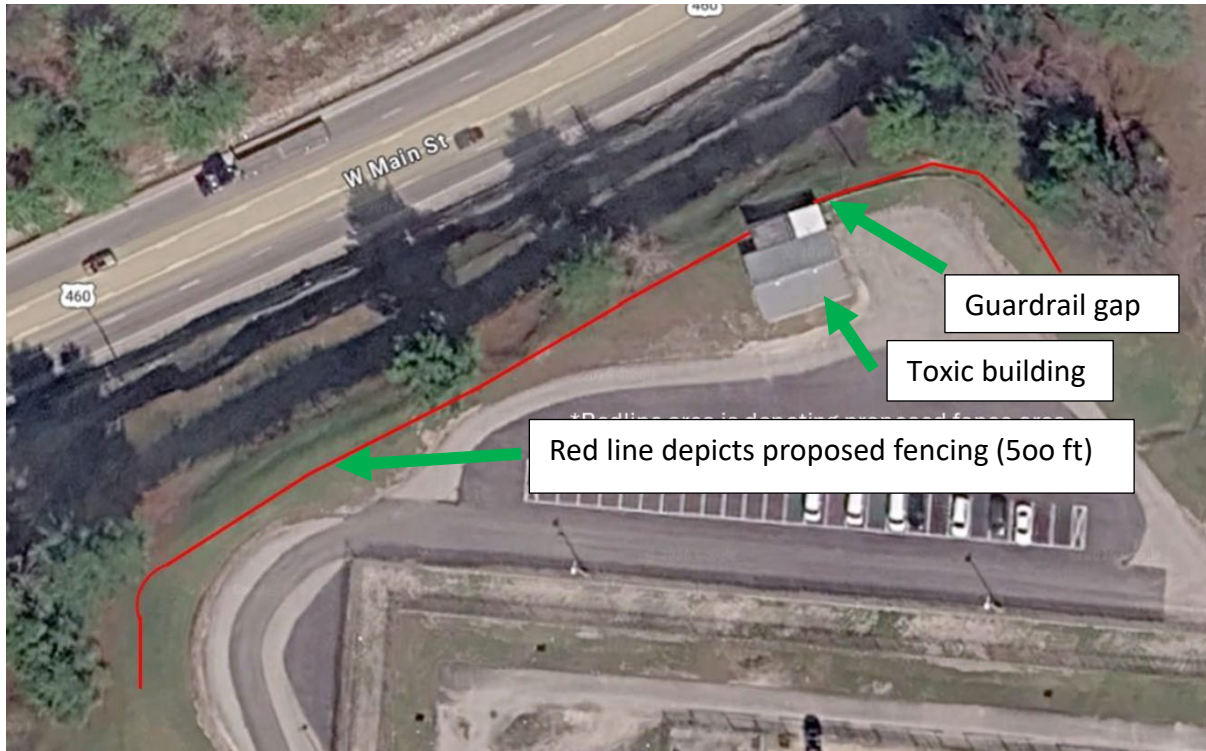
Figure 8: Aerial view, Toxic building and proposed fencing.

- Install a 6-foot-tall, 500 linear-foot fence with top and bottom rails in the area where Inmate Knuckles fell down the slope. The reason for a 6-foot-tall fence as opposed to a traditional 10-foot-tall security fence is that this fence is only a safety barrier to prevent falling in this area and will not be used to maintain custody or confinement. The area where the fence will be located is outside the secure perimeter of the facility; and
- Install signage that reads “No Entry Beyond This Point – Dangerous Slope”.
